# Inspection Report

## Sample Report

**Property Address:**  
123 Valley Rd  
Kitchener ON

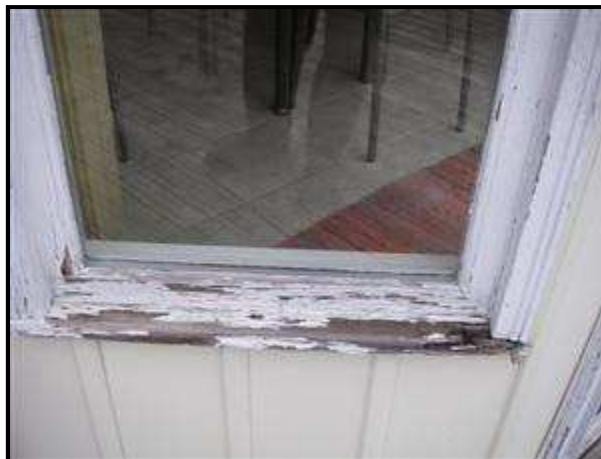
1.3 Picture 1

**1.3** (1) Wood rot/deterioration noted on main level wood framed windows. Immediate maintenance needed to prevent moisture entry into building envelop (seal openings with caulking, paint wood frames, consider capping with aluminum) Consider window upgrade including full frame replacement.

(1) Wood rot/deterioration noted on main level wood framed windows. Immediate maintenance needed to prevent moisture entry into building envelop (seal openings with caulking, paint wood frames, consider capping with aluminum) Consider window upgrade including full frame replacement.

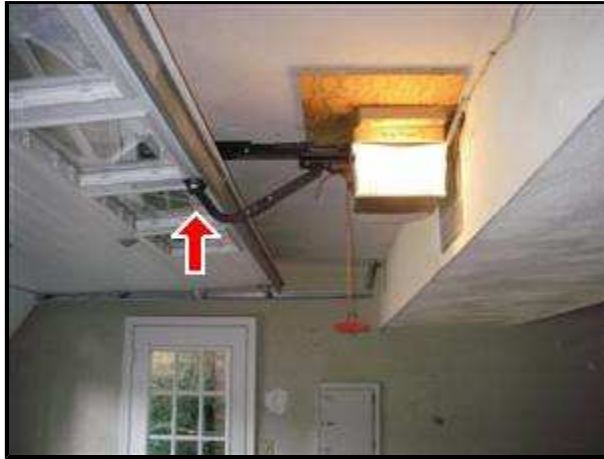
1.4 Picture 1

**1.4** Garage door does not open to full height of door opening. Adjustments needed for garage door to open to full height.

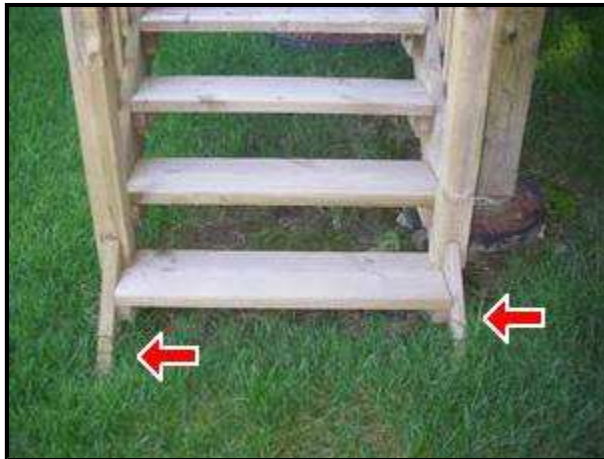
1.5 Picture 1

**1.5** Wood steps from deck sitting directly on soil. Wood soil contact may cause wood rot/settlement and premature deterioration of stairway. Recommend setting wood stringers on patio stone to prevent/reduce wood deterioration.

Wood steps from deck sitting directly on soil. Wood soil contact may cause wood rot/settlement and premature deterioration of stairway. Recommend setting wood stringers on patio stone to prevent/reduce wood deterioration.

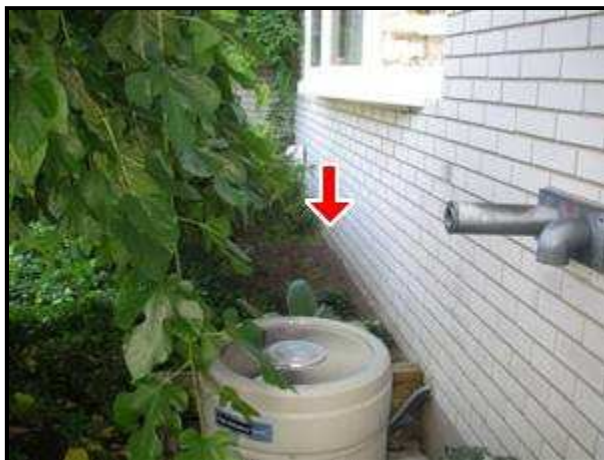
1.6 Picture 1

**1.6** (1) Soil is against the brick at the back side of the house. Recommend grading improvements to provide space between soil and first row of bricks to prevent moisture entry into the building envelop (ie. remove soil/mulch while providing slope away from foundation wall).

(1) Soil is against the brick at the back side of the house. Recommend grading improvements to provide space between soil and first row of bricks to prevent moisture entry into the building envelop (ie. remove soil/mulch while providing slope away from foundation wall).

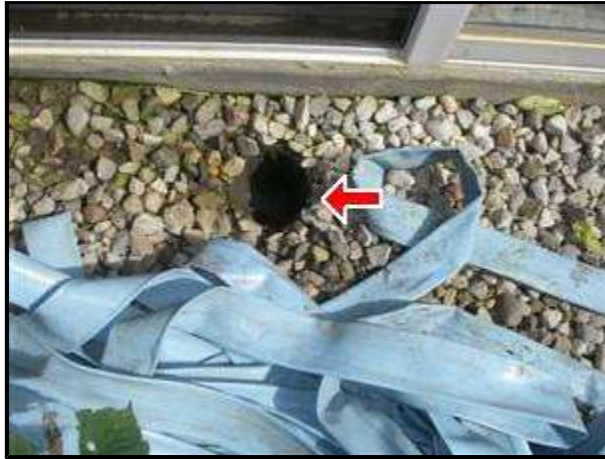
1.6 Picture 2

(2) Weep tile in window well missing cap. Install cap to prevent dirt/debris from plugging weep tile.

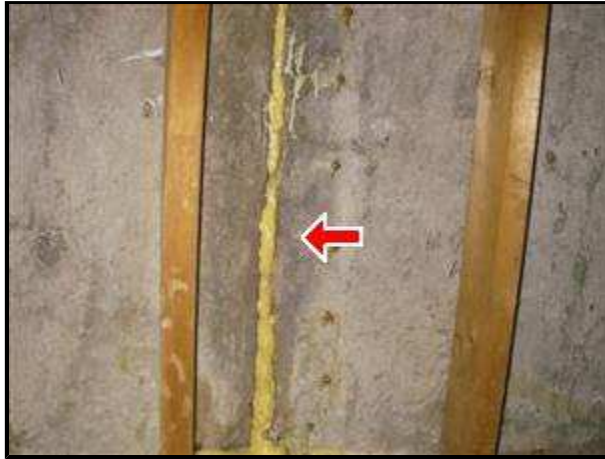
2.1 Picture 1

**2.1** (1) Repaired foundation crack (epoxy injection) noted in basement crawl space. No evidence of moisture in this area at time of inspection. This is generally a very successful repair method for concrete shrinkage type cracks.

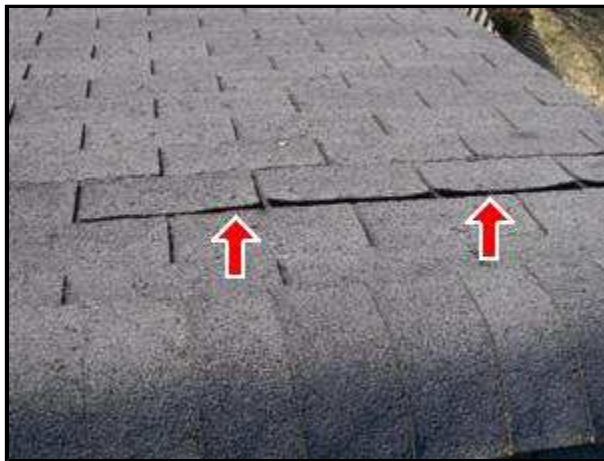
3.0 Picture 1

**3.0** Roof covering is showing signs of age and deterioration. Shingles split in approximately 4 locations, immediate repairs needed in these areas to prevent moisture entry into attic space. Budget for removal and replacement of shingles (complete roof covering) with the next 1 - 2 years.

Roof covering is showing signs of age and deterioration. Shingles split in approximately 4 locations, immediate repairs needed in these areas to prevent moisture entry into attic space. Budget for removal and replacement of shingles (complete roof covering) with the next 1 - 2 years.

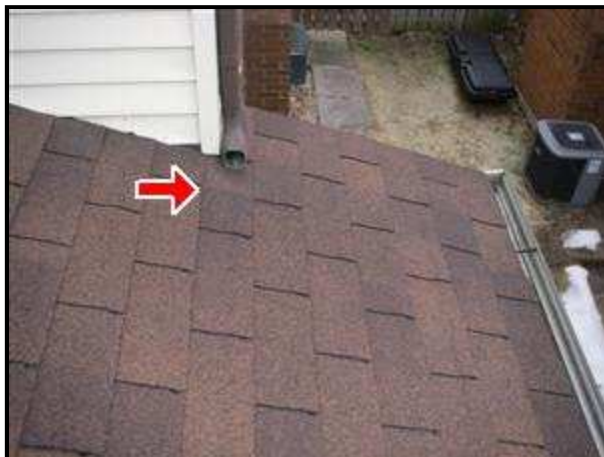
## 3.3 Picture 1

**3.3 (1)** Upper roof eave trough empties on to lower roof. This has the potential to wear the roof in localized areas. Recommend adding an additional downspout to prevent this roof wear.

(1) Upper roof eave trough empties on to lower roof. This has the potential to wear the roof in localized areas. Recommend adding an additional downspout to prevent this roof wear.

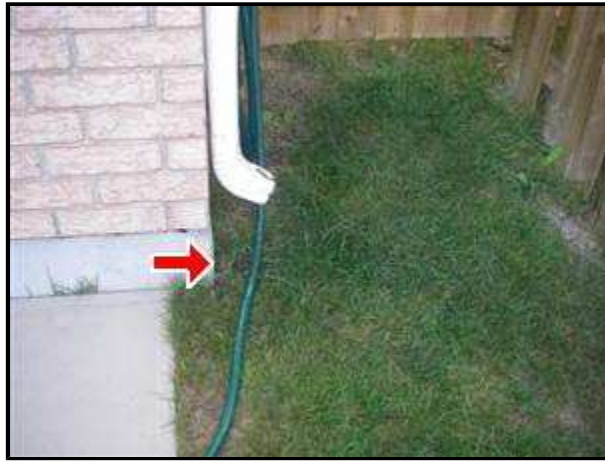
3.3 Picture 2

(2) Down spouts draining roof water beside the foundation. Recommend installing down spout extensions or splash pads as needed to ensure roof water is draining away from the foundation effectively.

(2) Down spouts draining roof water beside the foundation. Recommend installing down spout extensions or splash pads as needed to ensure roof water is draining away from the foundation effectively.

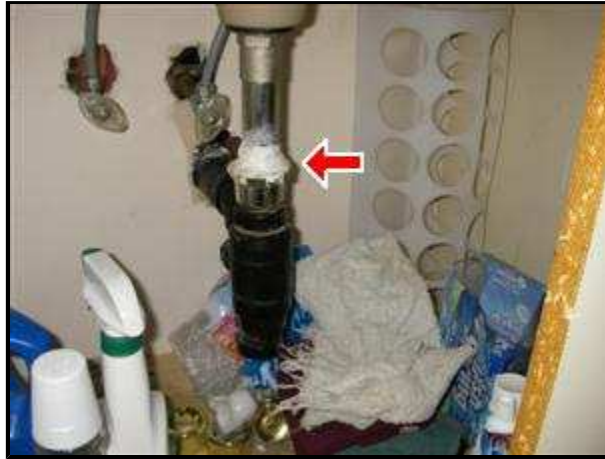
4.1 Picture 1

**4.1** Basement bathroom sink drain has temporary repair. Permanent repair needed to prevent moisture leaks.

Basement bathroom sink drain has temporary repair. Permanent repair needed to prevent moisture leaks.

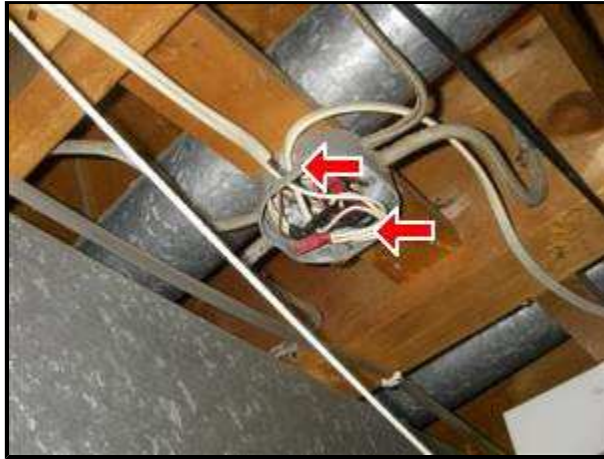
5.4 Picture 1

**5.4** Junction box in basement missing cover, missing proper wire holder - minor repair needed for your safety.

Junction box in basement missing cover, missing proper wire holder - minor repair needed for your safety.

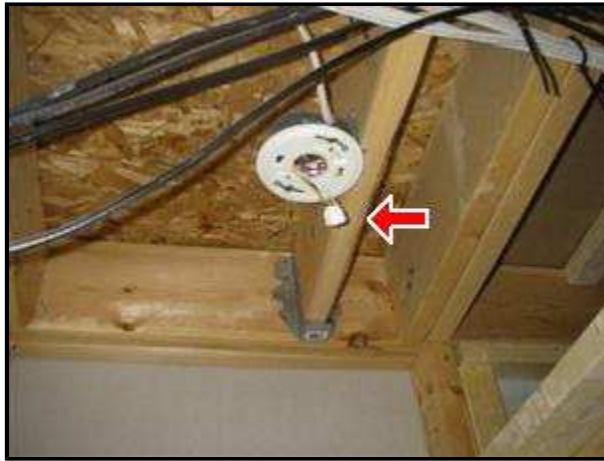
5.6 Picture 1

**5.6 (1)** Smoke detector missing in the basement. Smoke detectors are required on each level of the home.

(1) Smoke detector missing in the basement. Smoke detectors are required on each level of the home.

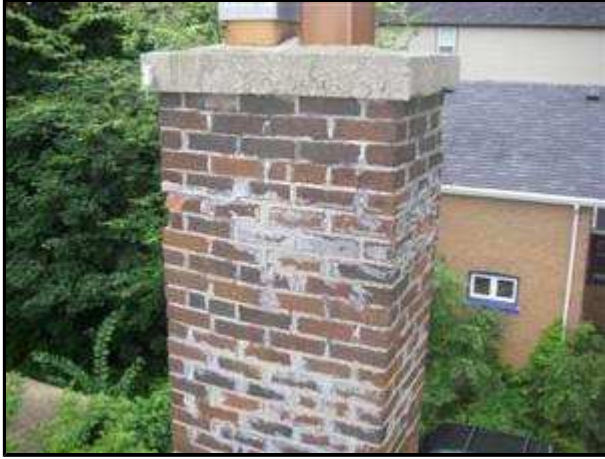
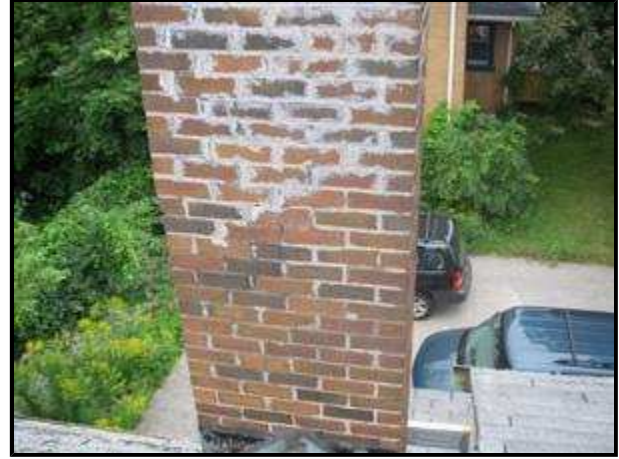
6.3 Picture 1

**6.3** (1) Brick and masonry deterioration with past repairs evident. This tall free standing chimney is unstable

and should be removed (currently not in use).

(1) Brick and masonry deterioration with past repairs evident. This tall free standing chimney is unstable and should be removed (currently not in use).

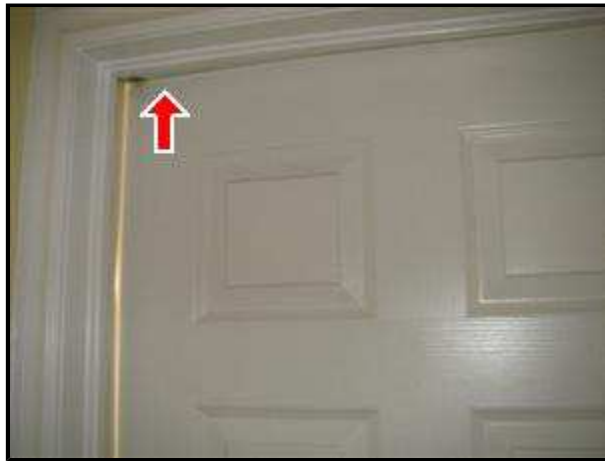
8.5 Picture 1

**8.5** Tight fitting bedroom door - trim door for improved opening and closing.

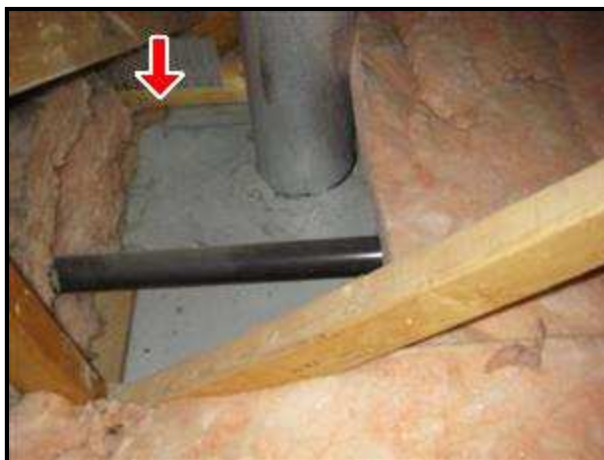
9.0 Picture 1

**9.0** Attic insulation pulled away from metal flue pipe. Re-install insulation in this small area to reduce heat loss.

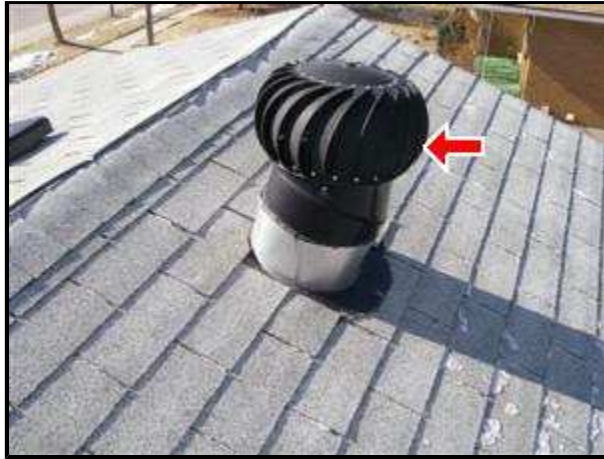
9.1 Picture 1

**9.1** Turbine style roof vent not spinning freely - replace bushings or replace/upgrade turbine vent.

Turbine style roof vent not spinning freely - replace bushings or replace/upgrade turbine vent.
